Upgrades Guide Avaya Communication Server 1000

Release 7.6 NN43001-408 Issue 01.03 November 2013 © 2013 Avaya Inc.

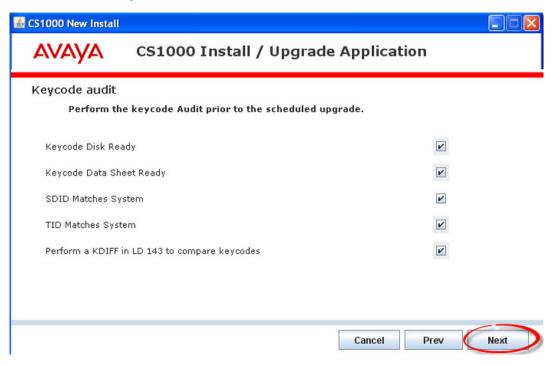
- 14. The **Keycode audit** screen appears, as shown.
 - Perform the Keycode Audit before the scheduled upgrade.
 - Place a check in each box.
 - Click Next to proceed.

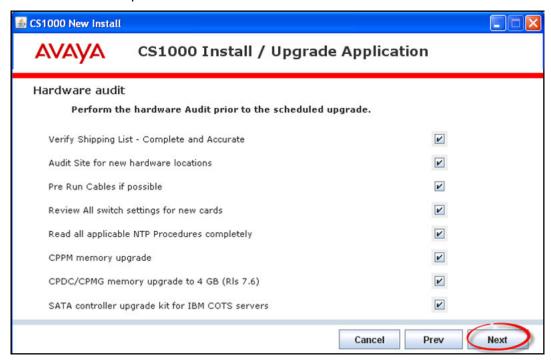
- 15. The **Hardware audit** screen appears, as shown.
 - Perform the required hardware audit tasks.
 - Place a check in each box.
 - Click Next to proceed.

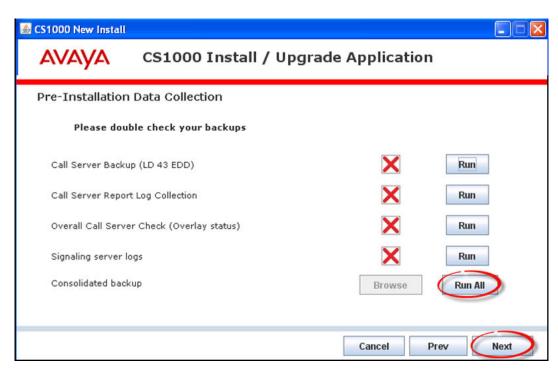
- 16. The Pre-Installation Data Collection screen appears, as shown.
 - Click the Run button for each individual item.
 - Or click the Run All button to run all of the data collection tasks.
 - Click Next to proceed when data collection tasks are completed.

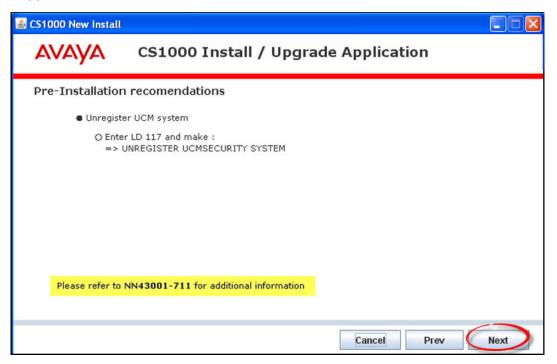
17. The **Pre-Installation recommendations** screen appears, as shown. Perform the suggested tasks and click **Next** to proceed.

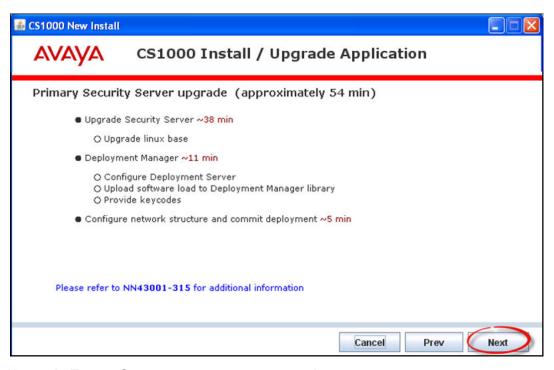
- 18. The **Primary Security Server upgrade** screen appears, as shown.
 - Complete the required tasks.
 - Click Next to proceed.

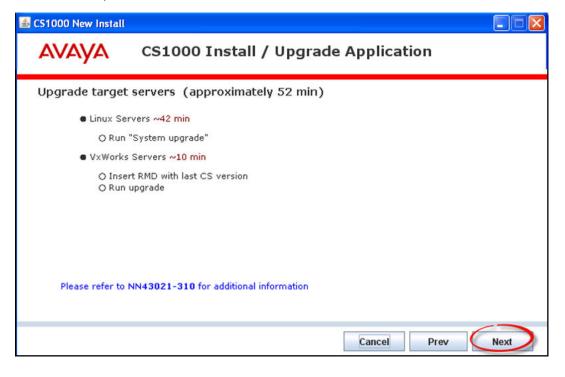
- 19. The **Upgrade Target Servers** screen appears, as shown.
 - Complete the required tasks.
 - Click Next to proceed.

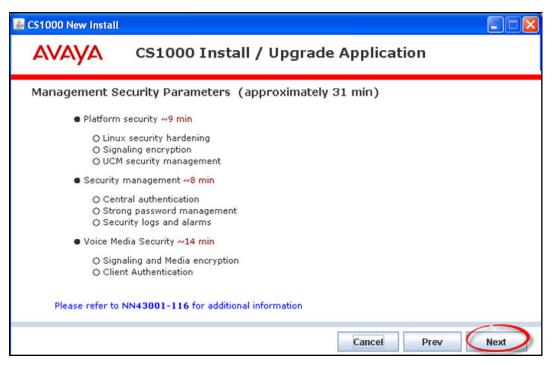
- 20. The Management Security Parameters screen appears, as shown.
 - Complete the required security configuration tasks.
 - Click Next to proceed.

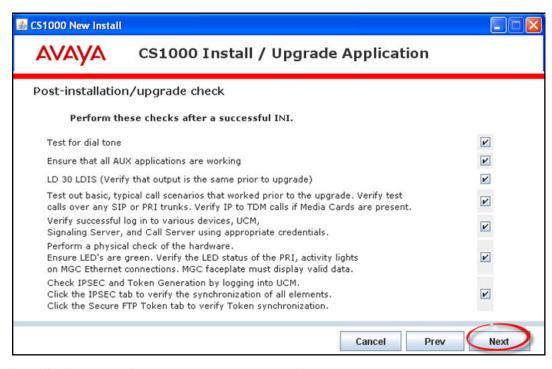
21. The **Post-Installation/upgrade** screen appears, as shown

- Perform the post-installation tasks listed, after a successful INI.
- Place a check in each box.
- Click **Next** to proceed.

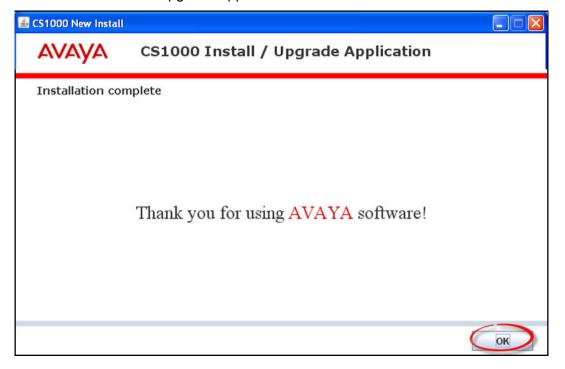
- 22. The **Installation complete** screen appears, as shown.
 - Click **OK** to exit the Upgrade Application.

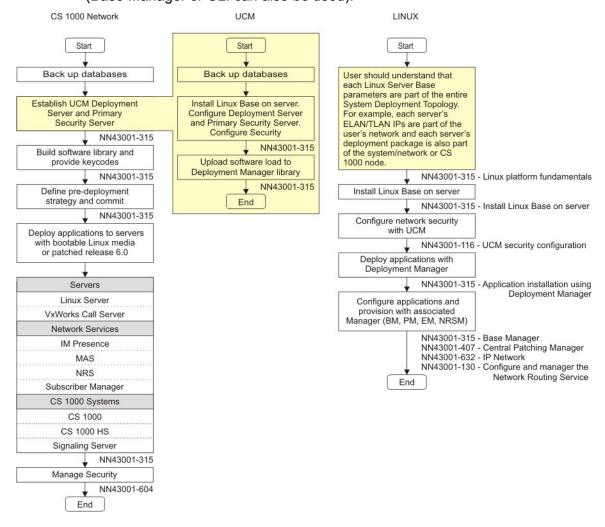
Release 7.0 upgrade procedure

- at installation or upgrade, then it will be required to reapply the SP after new applications are added.
- 6. Upgrade the member servers to Release 7.0 software using the Deployment Manager .
- 7. Install the Linuxbase SU to the Backup/Member Servers using UCM Patch Manager or CLI
- 8. Install the Baseweb and Patchweb SUs to the Backup/Member Servers using UCM Patch Manager.
- 9. Install the Service Pack to the Backup/Member Servers using UCM Patch Manager (Base Manager or CLI can also be used).

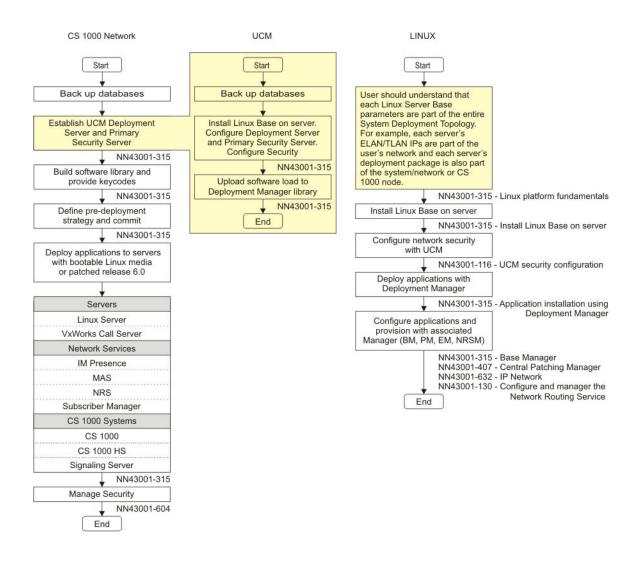
Release 7.5 upgrade procedure

- 5. Upgrade the member servers to Release 7.5 software using the Deployment Manager .
- Install the Linuxbase SU to the Backup/Member Servers using UCM Patch Manager or CLI.
- 7. Install the Baseweb and Patchweb SUs to the Backup/Member Servers using UCM Patch Manager.
- 8. Install the Service Pack to the Backup/Member Servers using UCM Patch Manager (Base Manager or CLI can also be used).

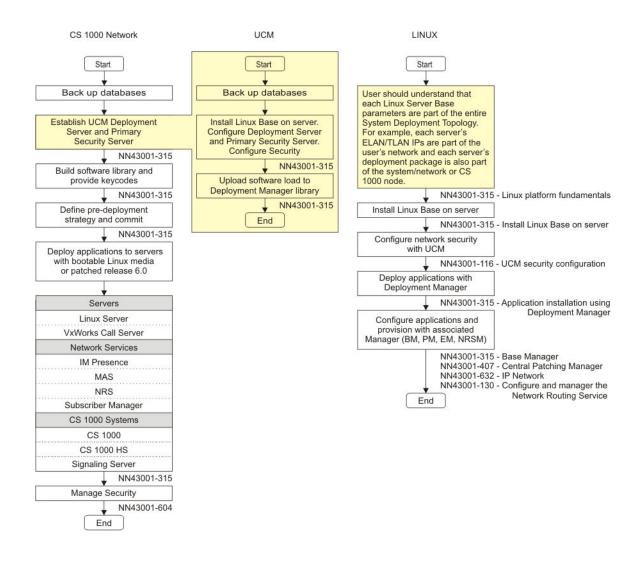
Release 7.6 upgrade procedure

- 5. Upgrade the member servers to Release 7.6 software using the Deployment Manager .
- Install the Linuxbase SU to the Backup/Member Servers using UCM Patch Manager or CLI.
- Install the Baseweb and Patchweb SUs to the Backup/Member Servers using UCM Patch Manager.
- 8. Install the Service Pack to the Backup/Member Servers using UCM Patch Manager (Base Manager or CLI can also be used).

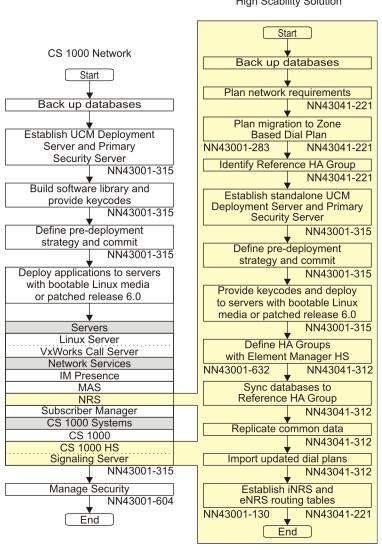
High Scability Solution

For details, see NN43041-312, Communication Server 1000E High Scalability Installation and Commissioning

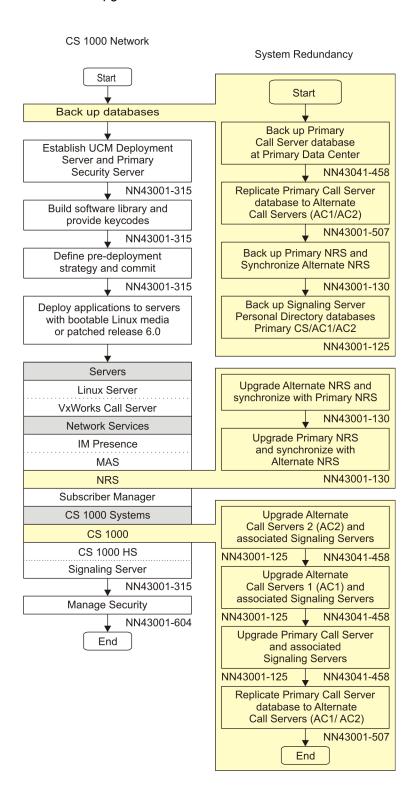
Geographic redundancy

All components must belong to the same UCM domain.

Cores Call Servers must have routes built to any ELAN device outside of their subnet.
